Illustrated guide to 13 common leaks

The Institute of Refrigeration, working with the Carbon Trust, brings you REAL Zero – Refrigerant Emission and Loss Zero. The aim of this project is in the title – zero refrigerant loss. The project offers practical assistance to everyone involved in purchasing, designing, installing, servicing, maintaining and owning refrigeration equipment to help them reduce leaks.

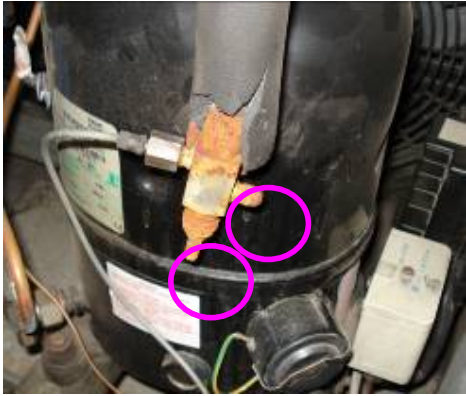
| Leak point | Likely causes | Solutions |
|---|--|--|
| <p>1. Shut-off and ball valves</p> | <ul style="list-style-type: none"> • Wear of the packing gland between the valve body and spindle shaft as it becomes compacted with age and use. • Overheating during installation. • Caps not fitted. | <ul style="list-style-type: none"> • Ensure that the gland is tightened. • Wrap the valve with a damp rag while brazing. <div style="background-color: #00FF00; padding: 5px; text-align: center; color: black; font-weight: bold;"> Always cap valves – most leaks occur at uncapped valves. </div> |

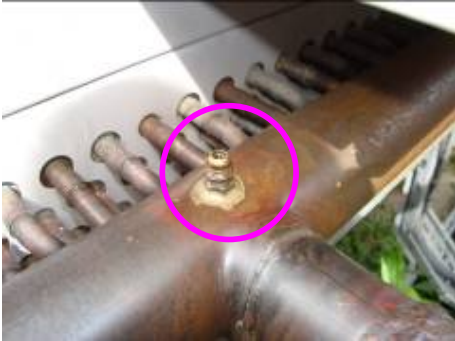
| Leak point | Likely causes | Solutions |
|---|--|--|
| <p>2. Schrader valves</p> | <p>Likely causes</p> <ul style="list-style-type: none"> • Valve cores damaged during brazing. • The cores not tightened correctly during replacement. • Deterioration of internal seals over time. • Caps not fitted or have no O-ring seal. | <p>Solutions</p> <ul style="list-style-type: none"> • Remove the core when brazing the fitting in; ensure the valve body has cooled before replacing the core. • Use the correct tool to replace / tighten the core. • Ensure the cap is fitted and has a seal (in good condition) in place. |

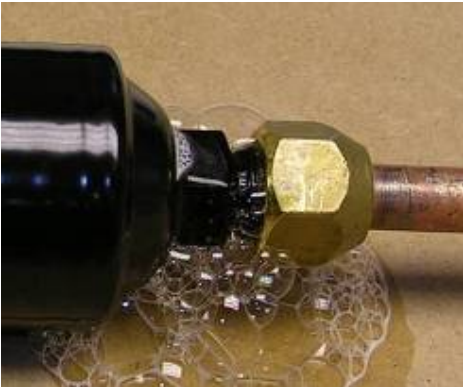
| Leak point | Likely causes | Solutions |
|---|--|--|
| <p>3. Flare joints</p> | <p>Likely causes</p> <ul style="list-style-type: none"> • Loosening of the flare nut due to thermal expansion / contraction due to a wide temperature variation, especially where those at the outlet of expansion valves. • Poor joint preparation (causing leakage from initial | <p>Solutions</p> <p>Where possible, avoid using flare connections. If they cannot be avoided:</p> <ul style="list-style-type: none"> • Use flare solder adaptors (factory produce flares). Ensure the copper seal is located correctly. • If you have to make a flare, cut the pipe work with a pipe cutter and de-burr using the correct tool. Use an eccentric flaring tool and ensure the correct amount of pipe is protruding through your flaring block. |

| <p>Flare joints continued..</p> | <p>installation).</p> <ul style="list-style-type: none"> • Over tightening, leading to damage at the copper flare face and the flare nut. • Under tightening of the flare. | <ul style="list-style-type: none"> • Check the flare size and that it does not foul the flare nut on the pipe. • Lubricate the flare and nut face with a small amount of refrigeration grade oil. • Don't over or under tighten the flare nut – use a torque wrench to the setting provided by the equipment manufacturer. |

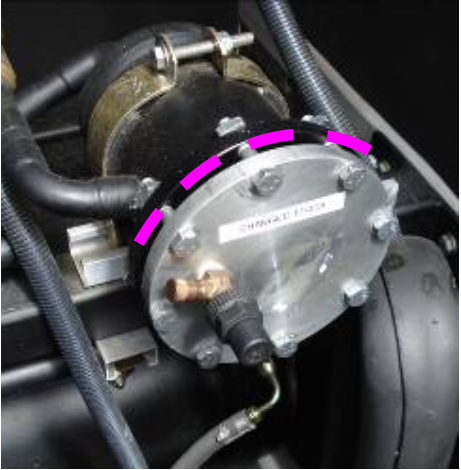
| <p>4. Mechanical joints and flanges</p> <p>There are a variety joints and flanges on a system e.g. drier core lids etc.</p> | <p>Likely causes</p> <ul style="list-style-type: none"> • Incorrectly prepared joint • Not replacing gaskets. • Uneven tightening of flanges. • Incorrectly torque used for tightening bolts. | <p>Solutions</p> <ul style="list-style-type: none"> • Avoid using PTFE on HFC refrigerants - use an appropriate thread sealant • Replace gaskets on flanges and remove all the old gasket material before applying the new one. • Tighten flanges down evenly applying the 'opposites' rule until the flange is seated correctly. • Use a torque wrench to carry out the final tensioning of flange bolts. |

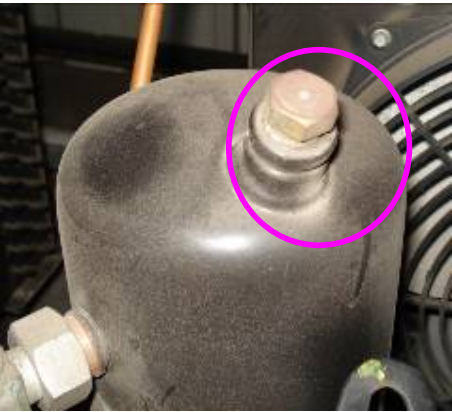
| <p>5. Pressure relief valves (PRVs) and fusible plugs (over-pressure protection)</p> | <p>Likely causes</p> <ul style="list-style-type: none"> • Fusible plugs – wide temperature and / or pressure variations weaken the bond between the solder core and the plug. • PRVs - do not reseat when the pressure drops after release and often leak across the PRV | <p>Solutions</p> <p>Fusible plugs</p> <ul style="list-style-type: none"> • Where possible, avoid using fusible plugs. If possible, replace them with a PRV. • Always leak test fusible plugs. <p>PRVs</p> <ul style="list-style-type: none"> • Always leak test the outlet of PRVs. • If a PRV is leaking replace it with an |

| <p>PRVs continued</p> | <p>seat during normal operation.</p> | <p>equivalent rated device.</p> <ul style="list-style-type: none"> Do not cap the PRV if it is leaking. Use dual PRVs with a change over valve where possible. Use a bursting disc in conjunction with the PRV where possible. It forms part of the PRV assembly and often has a tell tale gauge to indicate rupture. |

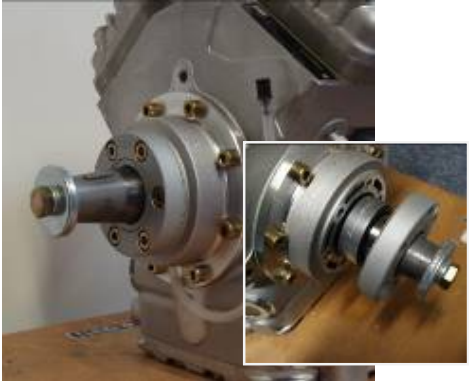
| <p>6. Shaft seals (open type compressors)</p> | <p>Likely causes</p> <ul style="list-style-type: none"> General wear over time, indicated by an increased oil loss from the shaft seal or refrigerant leakage. Lubrication failure. Incorrect fitting of a new shaft seal. Incorrect shaft alignment. Excessive crankshaft end float or bearing damage. | <p>Solutions</p> <ul style="list-style-type: none"> Regular observation of oil leakage rate into shaft seal collection vessel to check oil loss does not increase. Leak testing of the shaft seal with the compressor switched off. Using the correct type of shaft seal and following the proper procedure when replacing the shaft seal. |

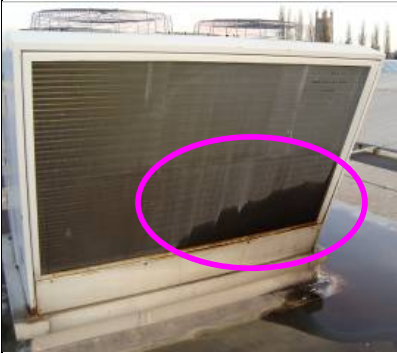
| <p>7. Condensers</p> | <p>Likely causes Shell and tube condensers</p> <ul style="list-style-type: none"> Corrosion of the copper and mild steel if the water circulating in the tubes is not treated correctly. Leaks can be particularly hard to locate, as they cannot be | <p>Solutions Shell and tube condensers</p> <ul style="list-style-type: none"> Ensure adequate corrosion prevention scheme is in place e.g. chemical dosing. Regular inspection to monitor potential corrosion level. Regular maintenance and monitoring. Where a leak has occurred in the tube bundle it is often false economy to |

| <p>condensers continued</p> | <p>seen – refrigerant might be detected in the water, but usually the leak is only detected by carrying out a full pressure test of the system.</p> <p>Air-cooled condensers</p> <ul style="list-style-type: none"> • Corrosion due to aggressive air. • Impact damage due to foreign bodies in the air stream. • Vibration causing premature failure of the tube bundle. | <p>replace one tube, as the rest of the tubes are probably in a similar condition and will fail.</p> <p>Air cooled condensers</p> <ul style="list-style-type: none"> • Always position condensers on a level base. • Repair or replace out of balance fans. • Check the fin block for signs of oil. • When replacing a condenser, select it carefully, especially if it is going into an aggressive environment e.g. on the coast. |

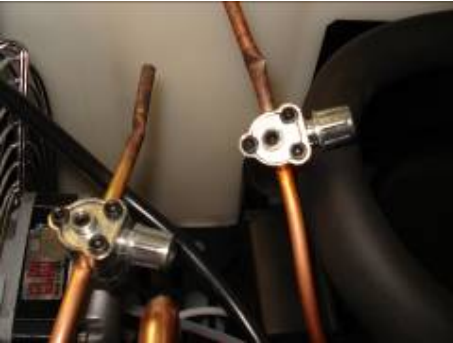
| <p>8. Line tap valves</p> | <p>Likely causes</p> <ul style="list-style-type: none"> • Poor fitting of the line tap onto the pipe, or being fitted to badly formed or flattened pipe work. • Use of the wrong size line tap • Loosening of the line tap valve due to movement and vibration. | <p>Solutions</p> <ul style="list-style-type: none"> • Ensure the correct size of tap valve is being used and read the instructions for its installation. • Fit a line tap to access a system, and then braze a Schrader connector to replace it – do not leave the line tap valve on the system. • Leak test any line taps found fitted and replace them if possible. |

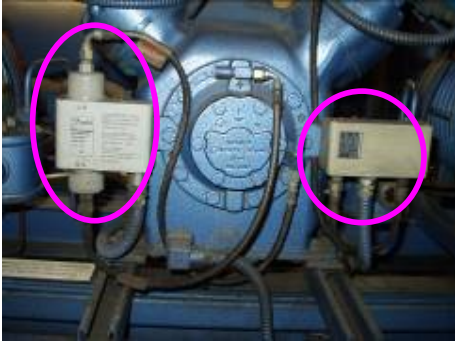
| Leak point | Likely causes | Solutions |
|--|--|---|
| <p>9. Pressure switches</p> | <ul style="list-style-type: none"> • Vibration causing the pressure coupler to split or damage to the pressure switch. • The pressure coupler chafing. • Rupture of the switch bellows due to vibration or liquid hydraulic action. • Failure of the flare connection onto the switch. • Poorly supported or fixed switch body. | <ul style="list-style-type: none"> • Use flexible pressure couplers where possible (stainless steel braided type offer a high degree of strength and mechanical protection). • Make sure pressure couplers do not rub or chafe on other pipes or vibrating surfaces. • Ensure the switch is correctly supported / fixed. • Use flare solder adaptors on the switch where copper pipe is being used. • Use dual bellows switches where possible. • Connect the switches to minimise the transfer of vibration into the switch. • Always leak test inside switches (be aware of the risk of electric shock). |

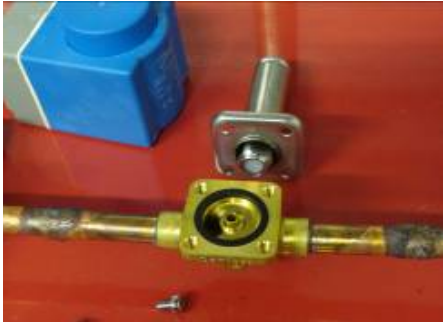
| Leak point | Likely causes | Solutions |
|--|--|---|
| <p>10. O-rings</p> <p>O-rings are widely used in components such as sight glasses, solenoid valves and shaft seals.</p> | <ul style="list-style-type: none"> • Wear, hardening or flattening, especially when subjected to extremes of temperature. • Leakage after retrofitting because of a different reaction to the new oil. | <ul style="list-style-type: none"> • Check (for roundness and flexibility) and change seals rather than re-using the existing ones, especially during a refrigerant retrofit. • Oil seals before fitting them. • Ensure the replacement seal is suitable for the system oil and refrigerant. |

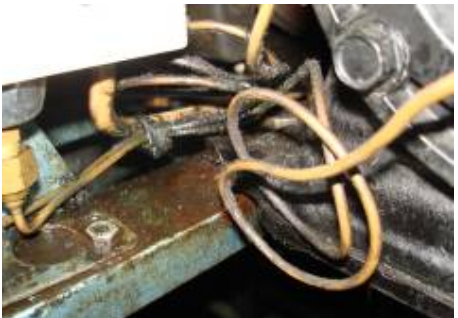
| Leak point | Likely causes | Solutions |
|---|---|---|
| <p data-bbox="235 262 673 325">11. Capillary tubes (pressure couplers and expansion devices)</p> | <ul data-bbox="730 262 974 535" style="list-style-type: none"> • Chafing due to insecure fixing. • Leakage where a capillary tube expansion device enters / exits the suction line. | <ul data-bbox="998 262 1323 388" style="list-style-type: none"> • Check capillary tubes are firmly located and cannot chafe – correct if necessary. |

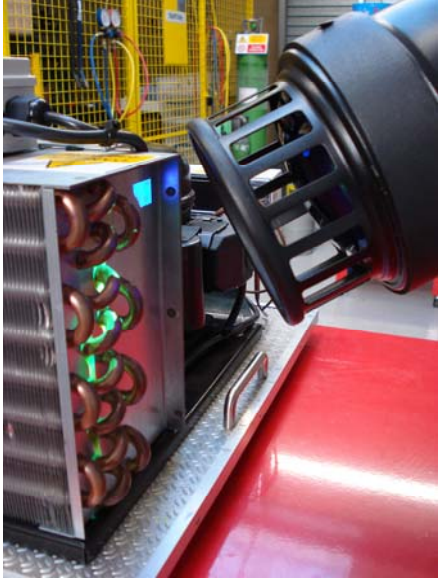
| Leak point | Likely causes | Solutions |
|---|---|---|
| <p data-bbox="235 724 673 787">12. Return bends on evaporators and condensers</p> | <p data-bbox="730 724 893 756">Likely cause</p> <ul data-bbox="730 766 974 1617" style="list-style-type: none"> • Corrosion due to chemical action on the return bends on coolers or air cooled condensers. Since the copper used in these heat exchangers is thinner than normal copper pipe work, a surface pinhole is likely to result in a leak in a relatively short period of time. Aggressive environments (such as a salty or acidic atmosphere) accelerate damage and hence leakage. | <p data-bbox="998 724 1128 756">Solutions</p> <ul data-bbox="998 766 1323 1522" style="list-style-type: none"> • Leak test return bends carefully, especially if the atmosphere is aggressive (e.g. in food factories where salad is washed in chlorine-treated water; where vinegar products are made; close to the sea). • If evaporators and condensers that are prone to leaks from return bends are to be replaced, specify materials which are less susceptible to damage such as coated or electro plated heat fin blocks. • When chemical cleaners are used ensure they are totally washed off. |

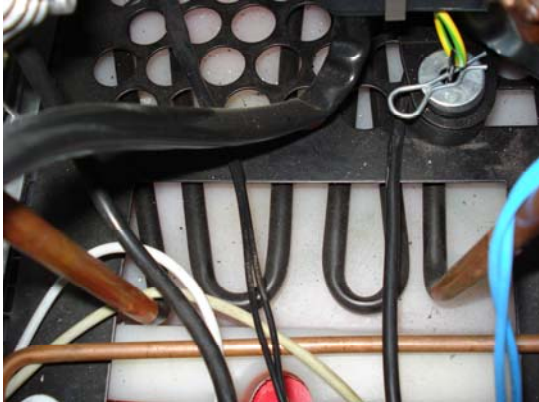
| Leak point | Likely causes | Solutions |
|---|---|---|
| <p data-bbox="235 262 641 294">13. Condensate tray pipe work</p> | <ul data-bbox="795 262 1047 420" style="list-style-type: none"> • Corrosion of the discharge line because of contact with air and water. | <ul data-bbox="1079 262 1323 787" style="list-style-type: none"> • Always leak test in the vaporiser tray and check the condition of the pipe work. If it is corroded, replace the pipe work before it fails. • Where possible, replace the pipe work with a plastic coated type as this extends the life dramatically. |
